**Flood Control Project Maintenance  
Levee Inspections**

**Fall 2015 Levee Maintenance Deficiency Summary Report**

**Reclamation District No. 0108 River Farms**

Waterway			Bank	Unit Miles
Unit No. 01 Colusa Basin Drain			Left	20.64
	Spring (March - May)	Summer (June - August)	(September - November) Fall	Winter (December - February)
Unit Maintenance Rating (Fall Only)			A	
Date of Inspection	04/20/2015 - 04/20/2015		09/24/2015 - 09/24/2015	
DWR Inspector	Jai Lor		Jai Lor	
Accompanied By

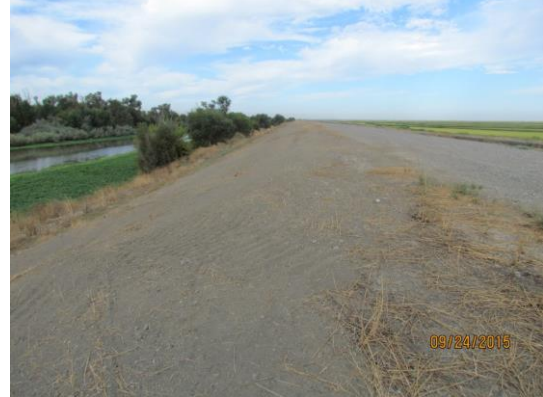
Photo 1 of 1 : FA\_2015\_RD0108\_203\_18\_20151001\_00009.jpg

View of the vegetation on the waterward side of the levee looking upstream. Fall 2015.

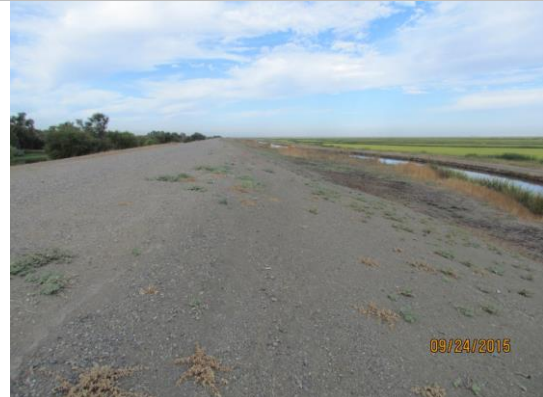
Photo 1 of 1 : FA\_2015\_RD0108\_203\_17\_20151001\_00010.jpg

LM Start	0.00	Rating **	A	Issue No.	17
LM End	20.64	Issue Type +	Ma	Location *	LS
Category	Earthen Levee			GPS Latitude/Longitude	
				Start	End
Item	Vegetation			38.822571 °	39.033889 °
				-121.796074 °	-121.993254 °
DWR ID	DWR_RD0108_01_f_2015_17				
Action/Comments					
Control annual grass and weeds on the levee slopes and easements. Inspector Comments: Vegetation on the slope have been cleared.

View of the vegetation on the landward side of the levee looking upstream. Fall 2015.

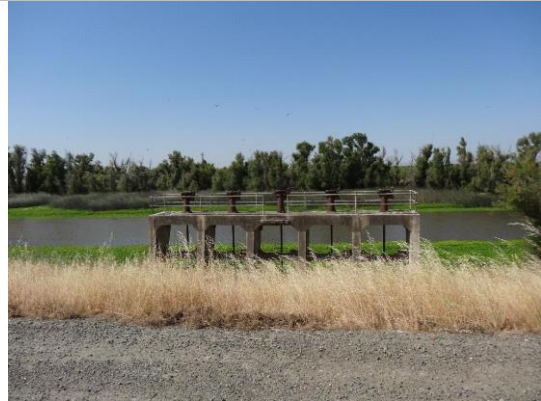
Photo 1 of 3 : UCIP\_FA\_2015\_6746.jpg

Inspector Comments: FS\_ID:37611  
 DS\_ID:22388  
 EP\_NO: 9396  
 FS\_HLM: 0.079  
 Repair Type: Non-Urgent  
 Crossing Status: Found  
 UCIP Comments: Need to contact owner to determine status of structure. Notes indicate crossing has been abandoned. Owner will need to coordinate with CVFPB and DWR inspector to determine how to properly abandon.  
 FIELD\_STRUCT\_DESC: 4 of 5. Five 72-inch abandoned pipes or culvert through levee 31.6 feet below crown. Slide gates on both ends. (App. 9736-RD 108) Ramp on landward slope. (App.9396-RD). O&M Manual SAC 132; October 1959  
 FS Date: 06/10/2014

Concrete structure located on waterward side.

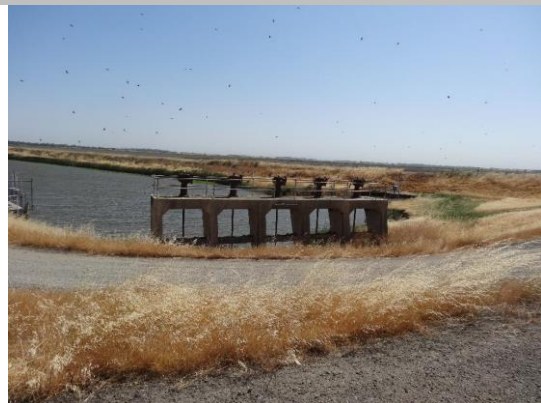
Photo 2 of 3 : UCIP\_FA\_2015\_6747.jpg

Concrete structure visible on landward side.

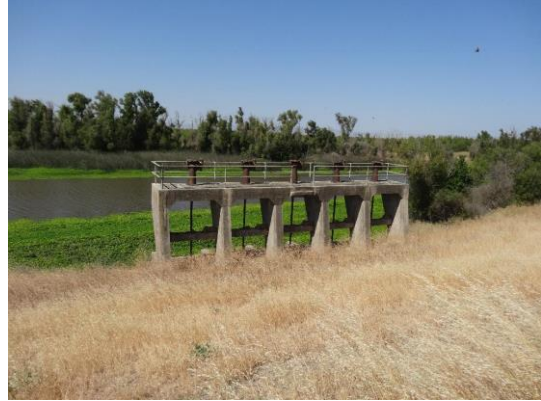
Photo 3 of 3 : UCIP\_FA\_2015\_6748.jpg

Waterward slope covered by dense vegetation.

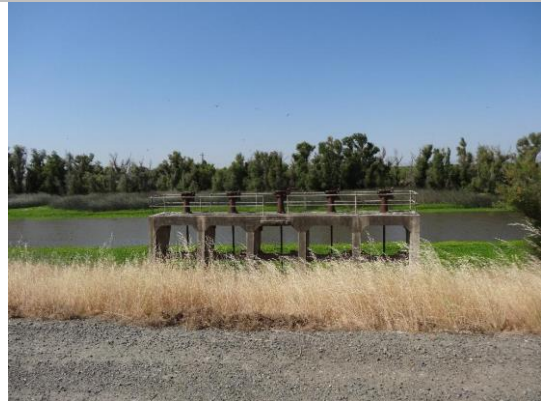
Photo 1 of 3 : UCIP\_FA\_2015\_6600.jpg

View of concrete structure visible on waterward side.

Inspector Comments: FS\_ID:37608  
 DS\_ID:17943  
 EP\_NO: 9396  
 FS\_HLM: 0.076  
 Repair Type: Non-Urgent  
 Crossing Status: Found  
 UCIP Comments: Need to contact owner to determine status of structure. Notes indicate crossing has been abandoned. Owner will need to coordinate with CVFPB and DWR inspector to determine how to properly abandon.  
 FIELD\_STRUCT\_DESC: 1 of 5. Five 72-inch abandoned pipes or culvert through levee 31.6 feet below crown. Slide gates on both ends. (App. 9736-RD 108) Ramp on landward slope. (App.9396-RD). O&M Manual SAC 132; October 1959  
 FS Date: 06/10/2014

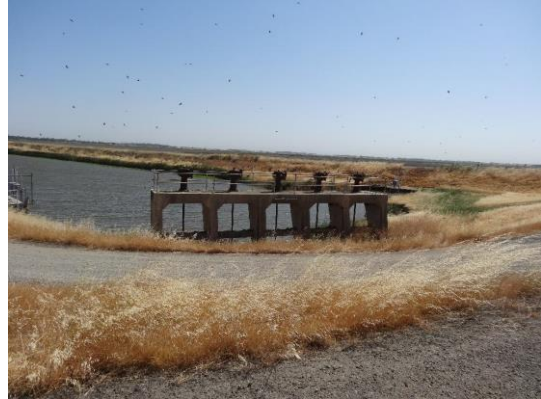
Photo 2 of 3 : UCIP\_FA\_2015\_6601.jpg

View of concrete structure visible on landward side.

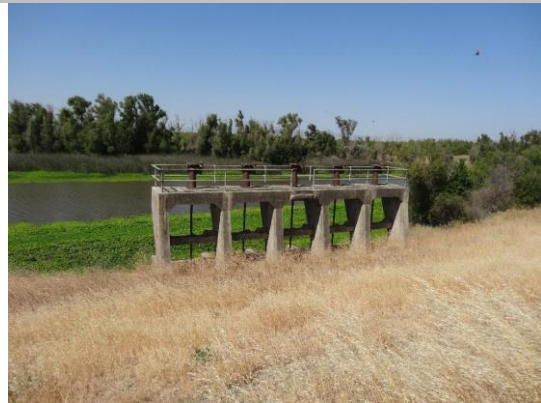
Photo 3 of 3 : UCIP\_FA\_2015\_6602.jpg

Dense vegetation on waterward side.

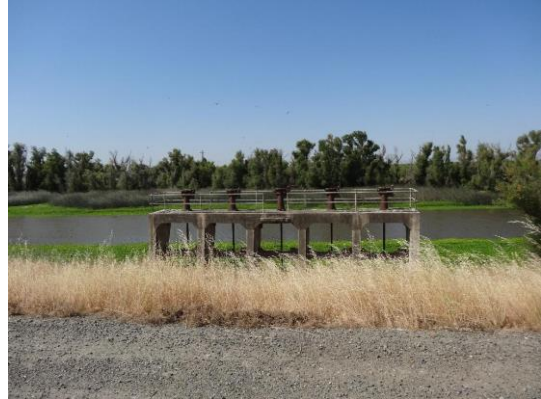
Photo 1 of 3 : UCIP\_FA\_2015\_6603.jpg

Concrete structure located on waterward side.

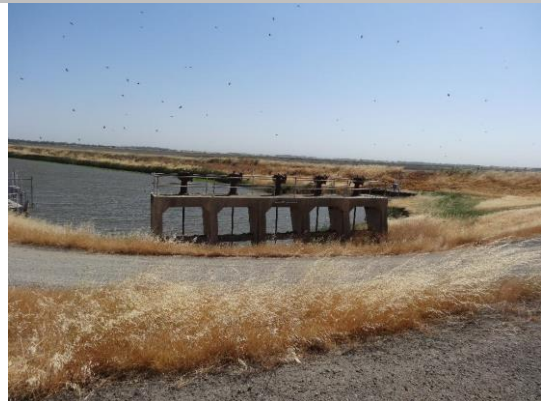
Photo 2 of 3 : UCIP\_FA\_2015\_6604.jpg

View of concrete structure located on landward side.

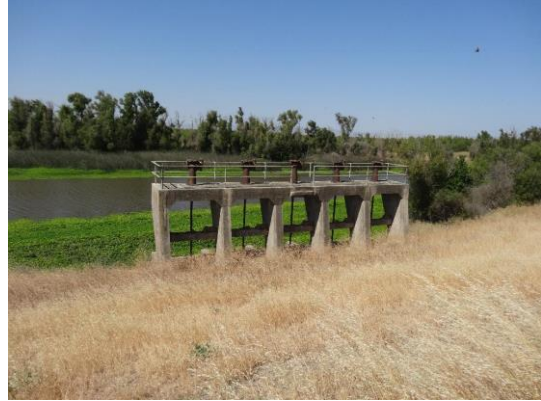
Photo 3 of 3 : UCIP\_FA\_2015\_6605.jpg

Dense vegetation covers the waterward slope.

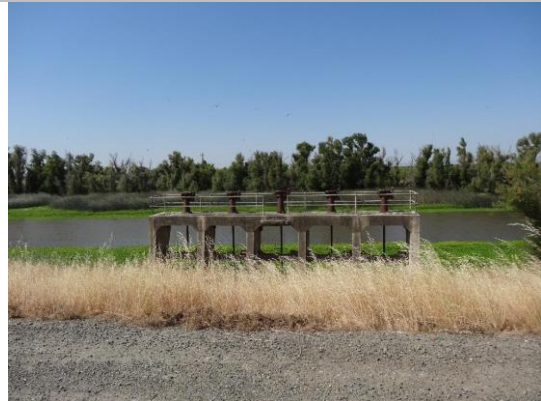
Photo 1 of 3 : UCIP\_FA\_2015\_6743.jpg

Concrete structure located on waterward side.

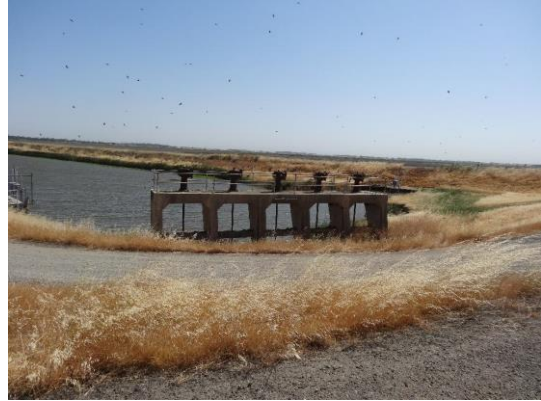
Photo 2 of 3 : UCIP\_FA\_2015\_6744.jpg

Concrete structure located on landward side.

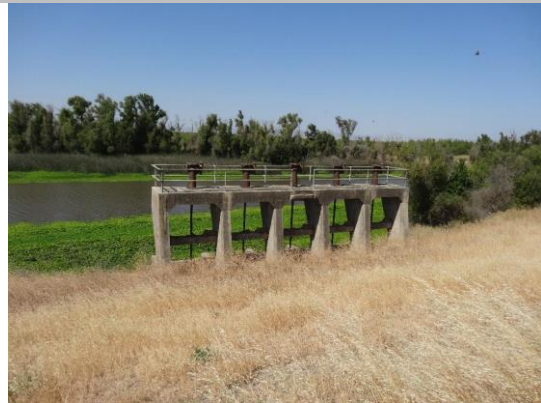
Photo 3 of 3 : UCIP\_FA\_2015\_6745.jpg

Dense vegetation covers waterward side slope.

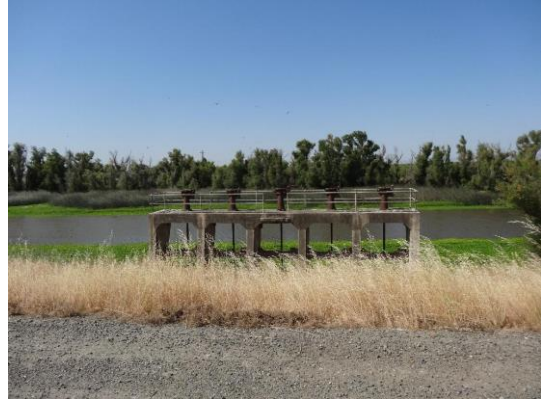
Photo 1 of 3 : UCIP\_FA\_2015\_6571.jpg

Concrete structure located on waterward side.

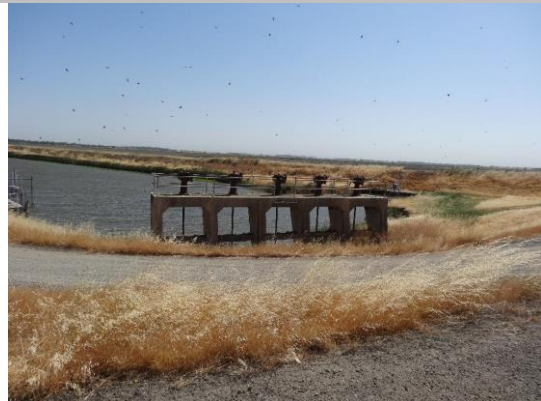
Photo 2 of 3 : UCIP\_FA\_2015\_6598.jpg

Concrete structure located on landward side.

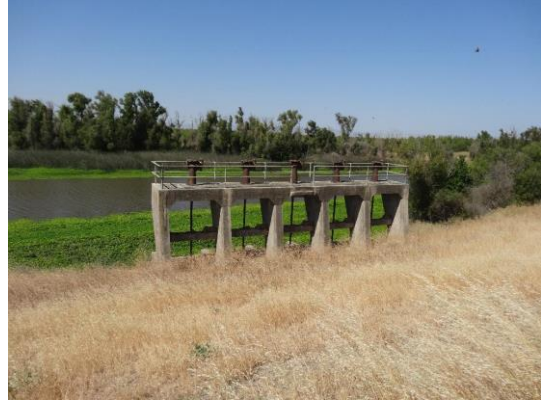
Photo 3 of 3 : UCIP\_FA\_2015\_6599.jpg

Waterward slope covered by dense vegetation.

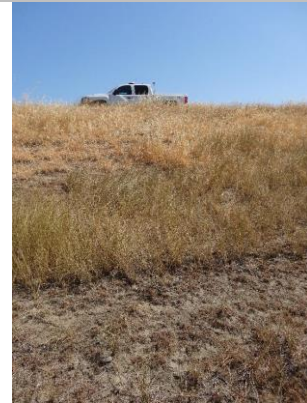
Photo 1 of 3 : UCIP\_FA\_2015\_6126.jpg

LM Start	2.91	Rating **	M	Issue No.	285
LM End	2.91	Issue Type +	En	Location *	LS
Category	Supplemental			GPS Latitude/Longitude	
				Start	End
Item	DWR UCIP Field Study			38.838696 °	38.838696 °
				-121.845843 °	-121.845843 °
DWR ID					
Action/Comments					
Inspector Comments: FS_ID:39707					
DS_ID:24875					
EP_NO: N/A					
FS_HLM: 2.92					
Repair Type: Non-Urgent					
Crossing Status: Indicator Found					
UCIP Comments: No signs of pipe visible--need to contact owner to obtain permit number authorizing work. If crossing is no longer used by owner, the owner will need to coordinate with DWR Inspector and CVFPB to remove crossing according to Title 23 requirements. Dense vegetation limits the inspector's visibility to identify signs of pipe failure (leaks) along the slope. Recommend removing vegetation along pipe alignment to conduct proper inspection of structure.					
FIELD_STRUCT_DESC: Corrugated Metal (CM) pipe riser located on waterward side. Riser is filled with trash and deris. Unable to determine if crossing exists at this location.

View of waterward slope.

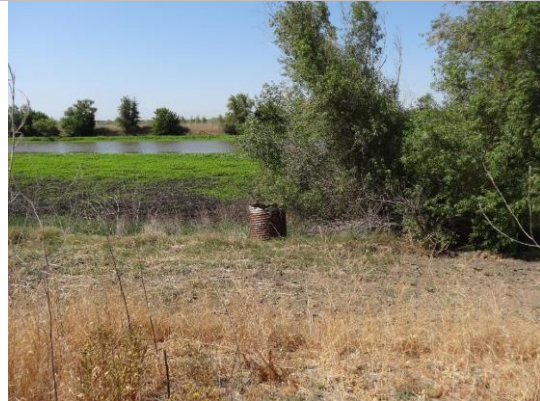
Photo 2 of 3 : UCIP\_FA\_2015\_6127.jpg

Item	DWR UCIP Field Study			38.838696 °	38.838696 °	
				-121.845843 °	-121.845843 °	
DWR ID						
Action/Comments						
Inspector Comments: FS_ID:39707						
DS_ID:24875						
EP_NO: N/A						
FS_HLM: 2.92						
Repair Type: Non-Urgent						
Crossing Status: Indicator Found						
UCIP Comments: No signs of pipe visible--need to contact owner to obtain permit number authorizing work. If crossing is no longer used by owner, the owner will need to coordinate with DWR Inspector and CVFPB to remove crossing according to Title 23 requirements. Dense vegetation limits the inspector's visibility to identify signs of pipe failure (leaks) along the slope. Recommend removing vegetation along pipe alignment to conduct proper inspection of structure.						
FIELD_STRUCT_DESC: Corrugated Metal (CM) pipe riser located on waterward side. Riser is filled with trash and deris. Unable to determine if crossing exists at this location.

CMP riser located on waterward toe--2/3 filled with soil and trash.

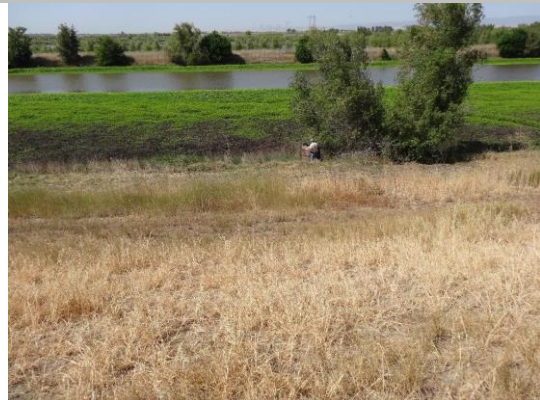
Photo 3 of 3 : UCIP\_FA\_2015\_6128.jpg

View of waterward side.

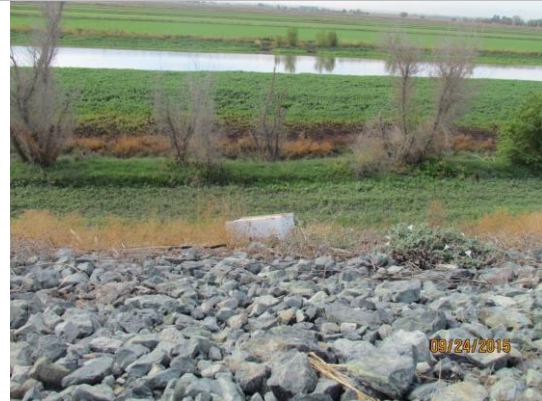
Photo 1 of 1 : FA\_2015\_RD0108\_203\_23\_20151001\_00011.jpg

View of the debris on the waterward side of the levee. Fall 2015.

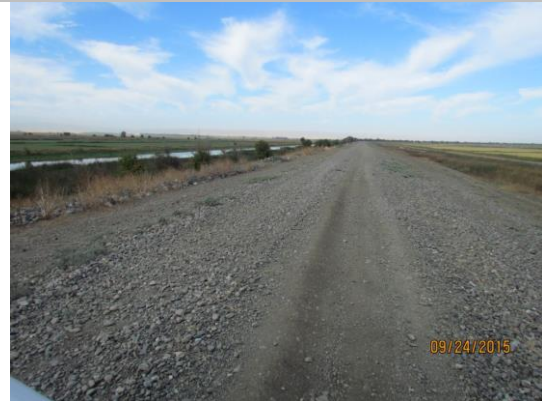
Photo 1 of 1 : FA\_2015\_RD0108\_203\_24\_20151001\_00012.jpg

View of the depression on the crown of the levee looking upstream. Fall 2015.

LM Start	4.17	Rating **	M	Issue No.	24
LM End	4.17	Issue Type +	Ma	Location *	CR
Category	Earthen Levee			GPS Latitude/Longitude	
				Start	End
Item	Crown Surface / Depressions / Rutting			38.843708 °	38.843708 °
				-121.868215 °	-121.868215 °
DWR ID	DWR_RD0108_01_f_2015_24				
Action/Comments					
Repair depressions or ruts in the crown or slope.

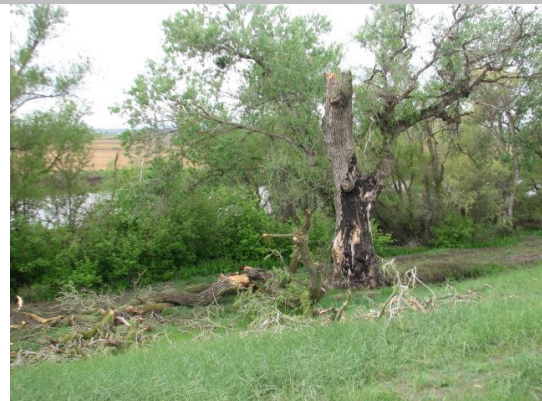
Photo 1 of 2 : FA\_2015\_RD0108\_203\_10\_20150914\_00005.jpg

LM Start	5.19	Rating **	A/W	Issue No.	10
LM End	5.19	Issue Type +	Ma	Location *	WS
Category	Earthen Levee			GPS Latitude/Longitude	
				Start	End
Item	Vegetation			38.846086 °	38.846086 °
				-121.886834 °	-121.886834 °
DWR ID	DWR_RD0108_01_s_2014_10				
Action/Comments					
Trees / Woody Vegetation					
Inspector Comments: Tree at the toe is dying.

Tree limbs are along the toe of the levee. Tree is slowing dying and could be a hazard to the levee. Spring 2014

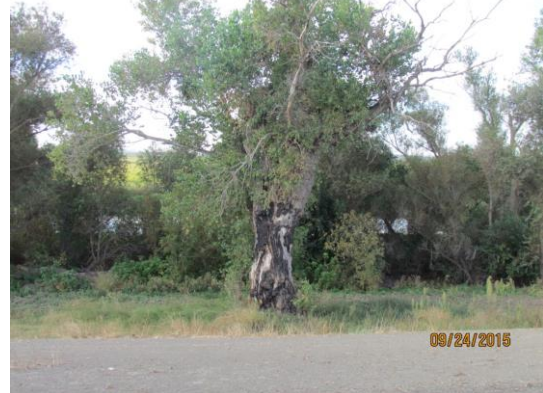
Photo 2 of 2 : FA\_2015\_RD0108\_203\_10\_20151001\_00013.jpg

Tree limbs have been removed but suggest monitoring the dying tree.  
Fall 2015.

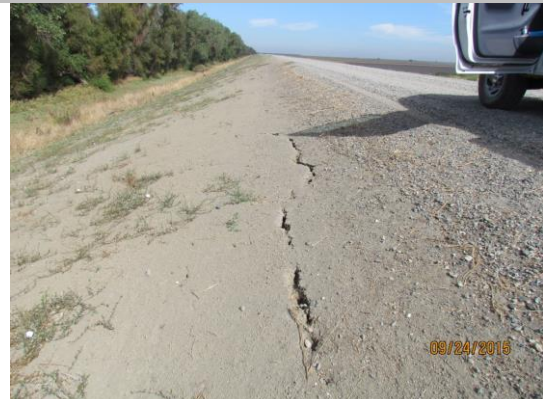
Photo 1 of 1 : FA\_2015\_RD0108\_203\_26\_20151001\_00014.jpg

View of the crack on the waterward side of the levee looking upstream.  
Suggest monitoring the crack. Fall 2015.

LM Start	8.27	Rating **	A/W	Issue No.	26
LM End	8.27	Issue Type +	Ma	Location *	WS
Category	Earthen Levee			GPS Latitude/Longitude	
				Start	End
Item	Cracking			38.882595 °	38.882595 °
				-121.914669 °	-121.914669 °
DWR ID	DWR_RD0108_01_f _ 2015_26				
Action/Comments					
Monitor and have inspected by geotechnical engineer.

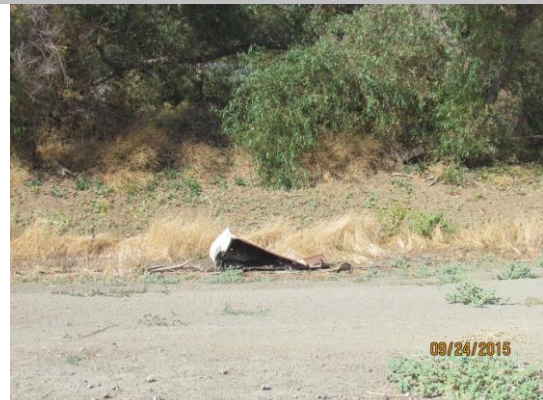
Photo 1 of 1 : FA\_2015\_RD0108\_203\_27\_20151001\_00015.jpg

LM Start	8.98	Rating **	M	Issue No.	27
LM End	8.98	Issue Type +	Ma	Location *	WS
Category	Earthen Levee			GPS Latitude/Longitude	
				Start	End
Item	Encroachments			38.892888 °	38.892888 °
				-121.914642 °	-121.914642 °
DWR ID	DWR_RD0108_01_f _ 2015_27				
Action/Comments					
Debris

View of the debris on the waterward side of the levee. Fall 2015.

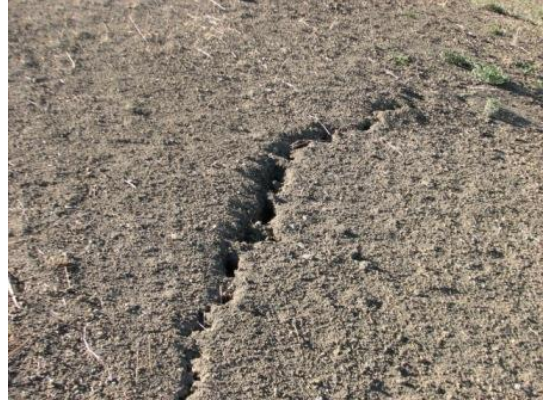
Photo 1 of 2 : FA\_2015\_RD0108\_203\_279\_20150914\_00007.jpg

The cracking runs in a horseshoe pattern on the levee slope. Fall 2013

LM Start	9.29	Rating **	A/W	Issue No.	279
LM End	9.29	Issue Type +	Ma	Location *	WS
Category	Earthen Levee			GPS Latitude/Longitude	
				Start	End
Item	Slope Stability			38.897452 °	38.897452 °
				-121.914680 °	-121.914680 °
DWR ID	DWR_RD0108_01_f_2013_279				
Action/Comments					
Repair slope instability.

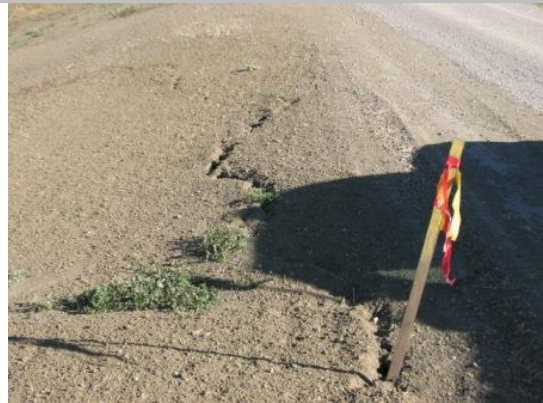
Photo 2 of 2 : FA\_2015\_RD0108\_203\_279\_20150914\_00008.jpg

Slope stability with cracking 1-2 inches open and 12 inches deep. The district is monitoring the site. Fall 2013

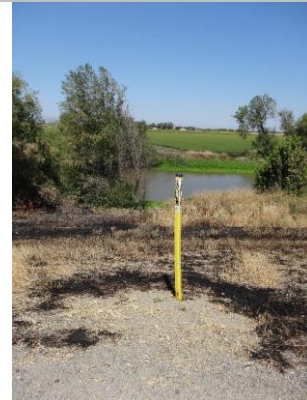
Photo 1 of 4 : UCIP\_FA\_2015\_6216.jpg

LM Start	11.24	Rating **	M	Issue No.	286
LM End	11.24	Issue Type +	En	Location *	WS
Category	Supplemental			GPS Latitude/Longitude	
				Start	End
Item	DWR UCIP Field Study			38.925662 °	38.925662 °
				-121.914303 °	-121.914303 °
DWR ID					
Action/Comments					
Inspector Comments: FS_ID:39717 DS_ID:24876 EP_NO: N/A FS_HLM: 11.22 Repair Type: Non-Urgent Crossing Status: Indicator Found

Marker visible on waterward side.

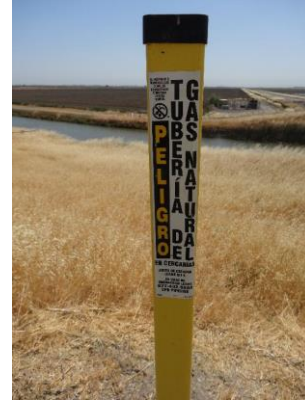
Photo 2 of 4 : UCIP\_FA\_2015\_6217.jpg

Owner contact information listed on marker.

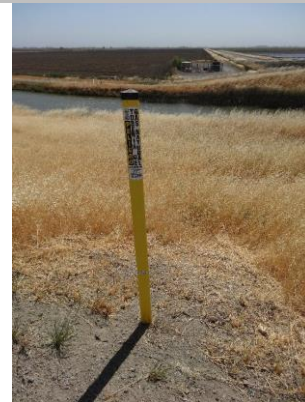
Photo 3 of 4 : UCIP\_FA\_2015\_6218.jpg

View of marker visible on shoulder.

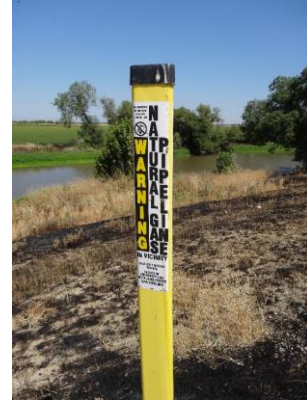
Photo 4 of 4 : UCIP\_FA\_2015\_6219.jpg

Waterward side marker indicating natural gas pipeline.

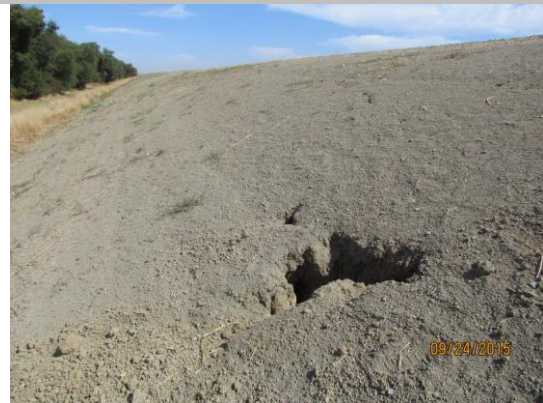
Photo 1 of 1 : FA\_2015\_RD0108\_203\_28\_20151001\_00016.jpg

View of the animal hole on the waterward side of the levee looking upstream. Fall 2015.

LM Start	11.64	Rating **	M	Issue No.	28
LM End	11.64	Issue Type +	Ma	Location *	WS
Category	Earthen Levee			GPS Latitude/Longitude	
				Start	End
Item	Animal Control			38.930980 °	38.930980 °
				-121.911489 °	-121.911489 °
DWR ID	DWR_RD0108_01_f_2015_28				
Action/Comments					
No rodents visible, but rodent burrows visible; need to backfill and compact or grout burrows.

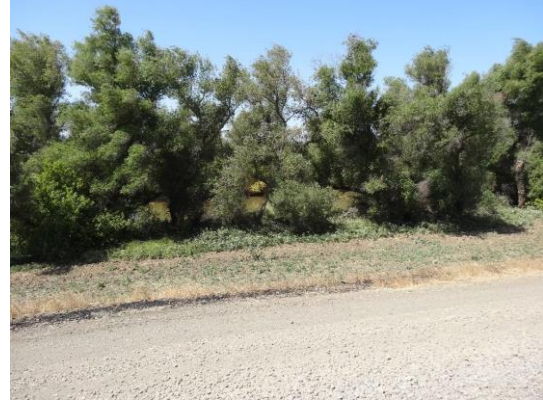
Photo 1 of 3 : UCIP\_FA\_2015\_6749.jpg

LM Start	14.94	Rating **	M	Issue No.	287
LM End	14.94	Issue Type +	En	Location *	LS
Category	Supplemental			GPS Latitude/Longitude	
				Start	End
Item	DWR UCIP Field Study			38.971607 °	38.971607 °
				-121.929499 °	-121.929499 °
DWR ID					
Action/Comments					
Inspector Comments: FS_ID:37623 DS_ID:17942 EP_NO: 3800 FS_HLM: 14.9 Repair Type: Non-Urgent Crossing Status: Indicator Found UCIP Comments: Need to contact owner--marker missing on waterward side. FIELD_STRUCT_DESC: 20-inch concrete encased gas line through levee, 3.0 feet below the crown. Crossing appears to be angled through levee (App. 3800-PG&E) Small rock revetment on the waterward slope. (unable to locate) Gas well approximately 1,000 feet from landward toe. FS Date: 06/10/2014

View of waterward side. No marker visible on waterward side.

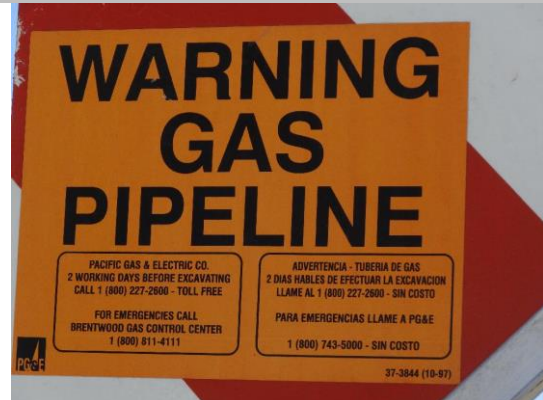
Photo 2 of 3 : UCIP\_FA\_2015\_6750.jpg

Contact information for gas line going through levee.

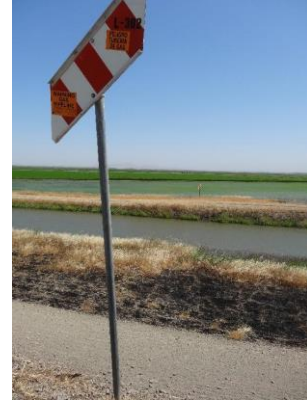
Photo 3 of 3 : UCIP\_FA\_2015\_6751.jpg

Marker visible on landward side.

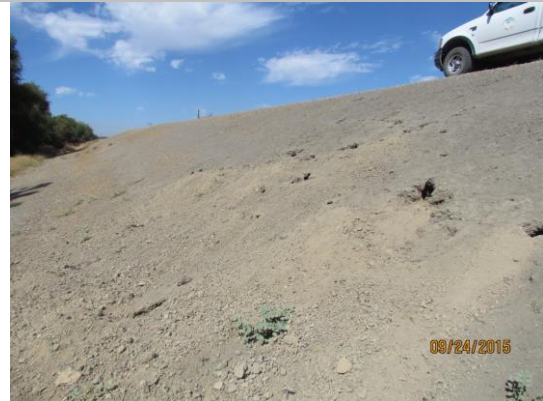
Photo 1 of 1 : FA\_2015\_RD0108\_203\_29\_20151001\_00017.jpg

View of the animal hole on the waterward side of the levee looking upstream. Fall 2015.

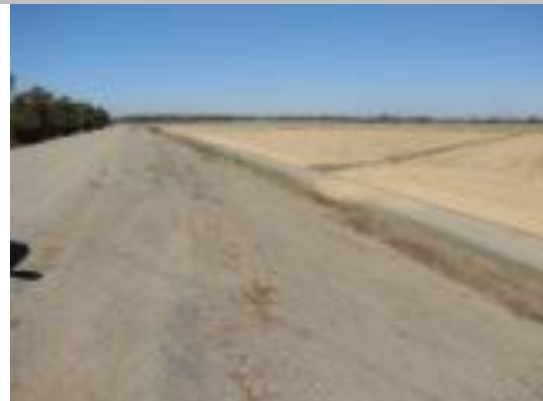
Photo 1 of 2 : FA\_2015\_RD0108\_203\_6\_20150914\_00003.jpg

Agricultural ditch along toe of landside. Photo taken fall 2011.

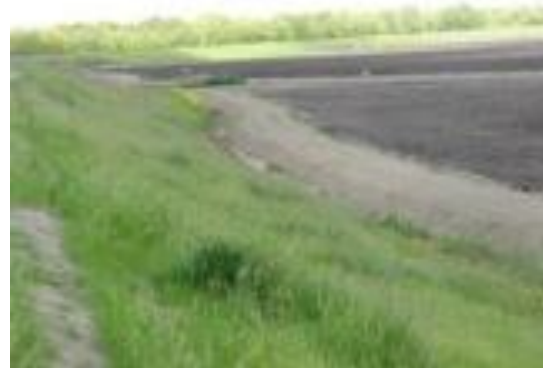
Photo 2 of 2 : FA\_2015\_RD0108\_203\_6\_20150914\_00004.jpg

Agricultural ditch

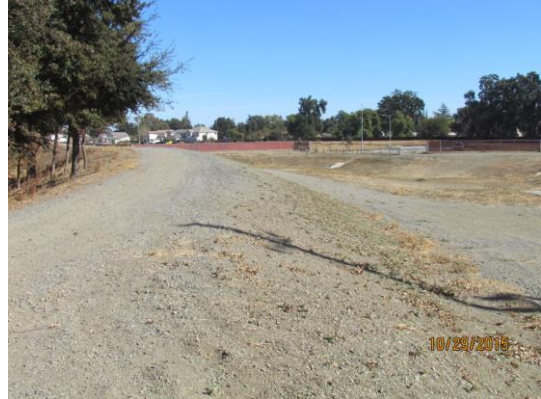
Photo 1 of 1 : FA\_2015\_RD0108\_590\_2\_20151103\_00005.jpg

View of the vegetation on the landward side of the levee looking downstream. Fall 2015.

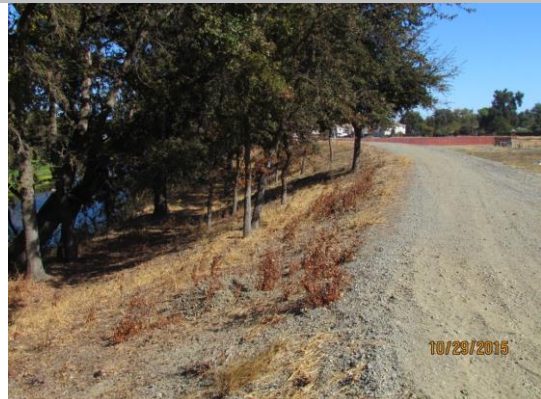
Photo 1 of 1 : FA\_2015\_RD0108\_590\_1\_20151103\_00004.jpg

View of the vegetation on the waterward side of the levee looking downstream. Fall 2015.

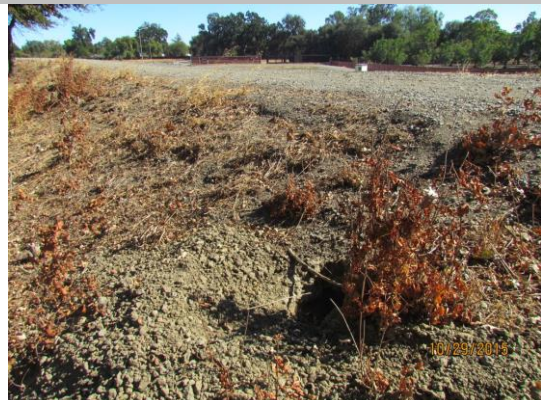
Photo 1 of 1 : FA\_2015\_RD0108\_590\_6\_20151103\_00006.jpg

View of the rodent hole on the waterward side of the levee looking downstream. Fall 2015.

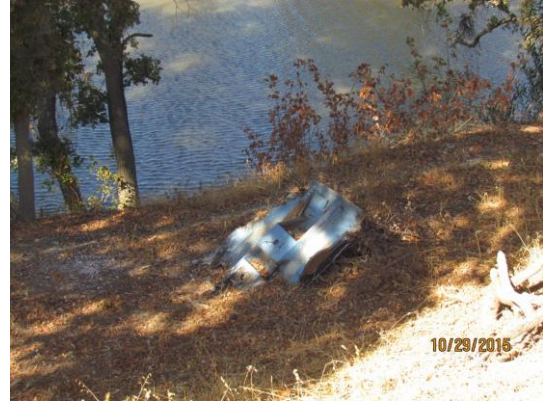
Photo 1 of 1 : FA\_2015\_RD0108\_590\_7\_20151103\_00007.jpg

View of debris at the toe of the waterward side of the levee. Fall 2015.

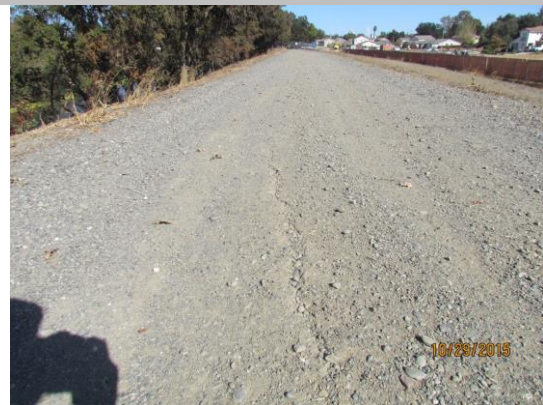
Photo 1 of 1 : FA\_2015\_RD0108\_590\_8\_20151103\_00008.jpg

View of the crack on the crown of the levee looking downstream. Fall 2015.

LM Start	0.14	Rating **	A/W	Issue No.	8
LM End	0.15	Issue Type +	Ob	Location *	CR
Category	Earthen Levee			GPS Latitude/Longitude	
				Start	End
Item	Cracking			38.797632 °	38.797760 °
				-121.726162 °	-121.726070 °
DWR ID	DWR_RD0108_02_f_2015_8				
Action/Comments					
Monitor and have inspected by geotechnical engineer.

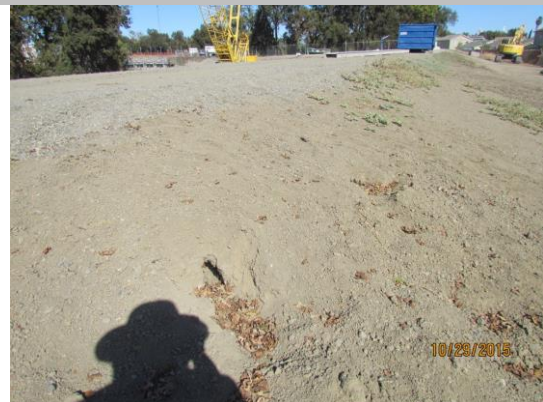
Photo 1 of 1 : FA\_2015\_RD0108\_590\_10\_20151103\_00009.jpg

View of the rodent hole on the landward side of the levee looking downstream. Fall 2015.
